# IN-SERVICE PERFORMANCE AND COSTS OF METHODS TO CONTROL URBAN RAIL SYSTEM NOISE

## SECOND TEST SERIES REPORT

INTERIM REPORT

U.S. DEPARTMENT OF TRANSPORTATION  
URBAN MASS TRANSPORTATION ADMINISTRATION  
Office of Technology Development and Deployment  
Office of Rail and Construction Technology  
Washington DC 20590

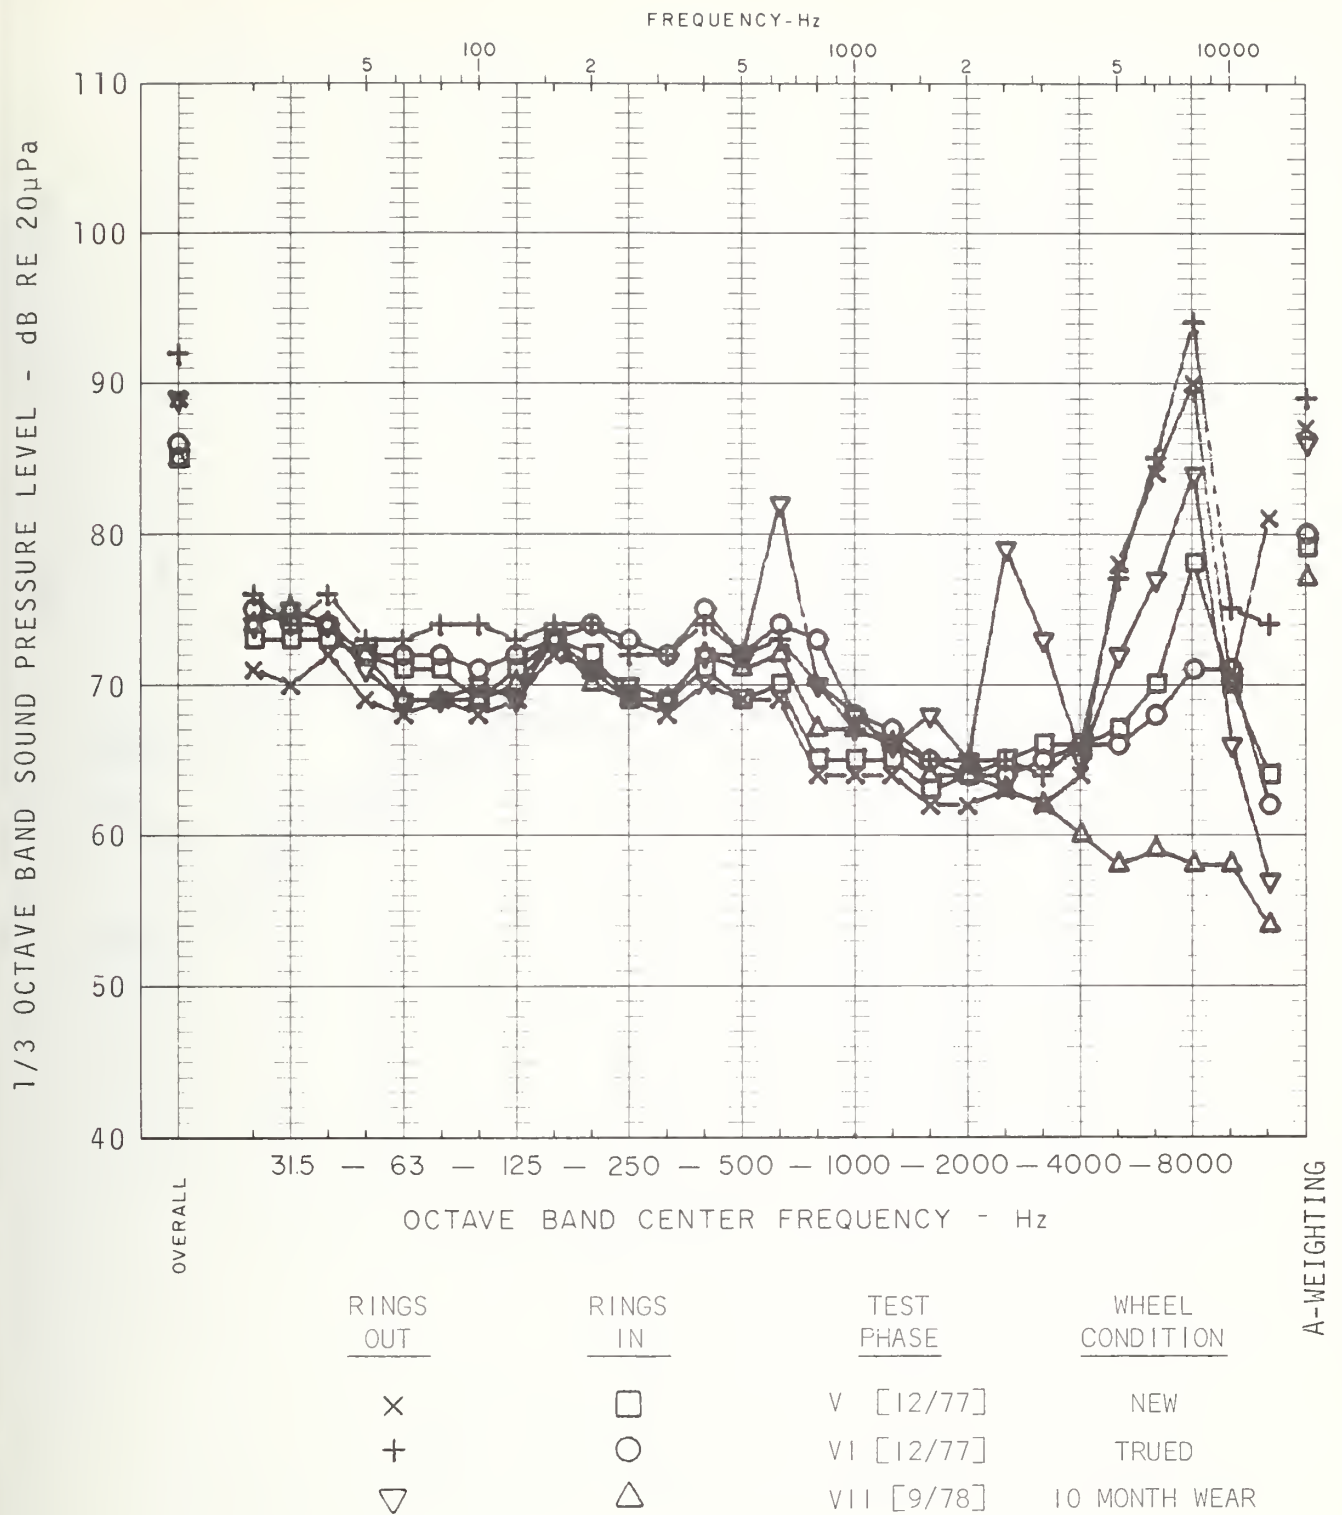
FIGURE 4-22. COMPARISON OF WHEEL SQUEAL WAYSIDE NOISE SPECTRA AT THE TURN TRACK FOR CARS 607/644 - AVERAGE OF SPECTRA ON GROUND AND WORN RAILS

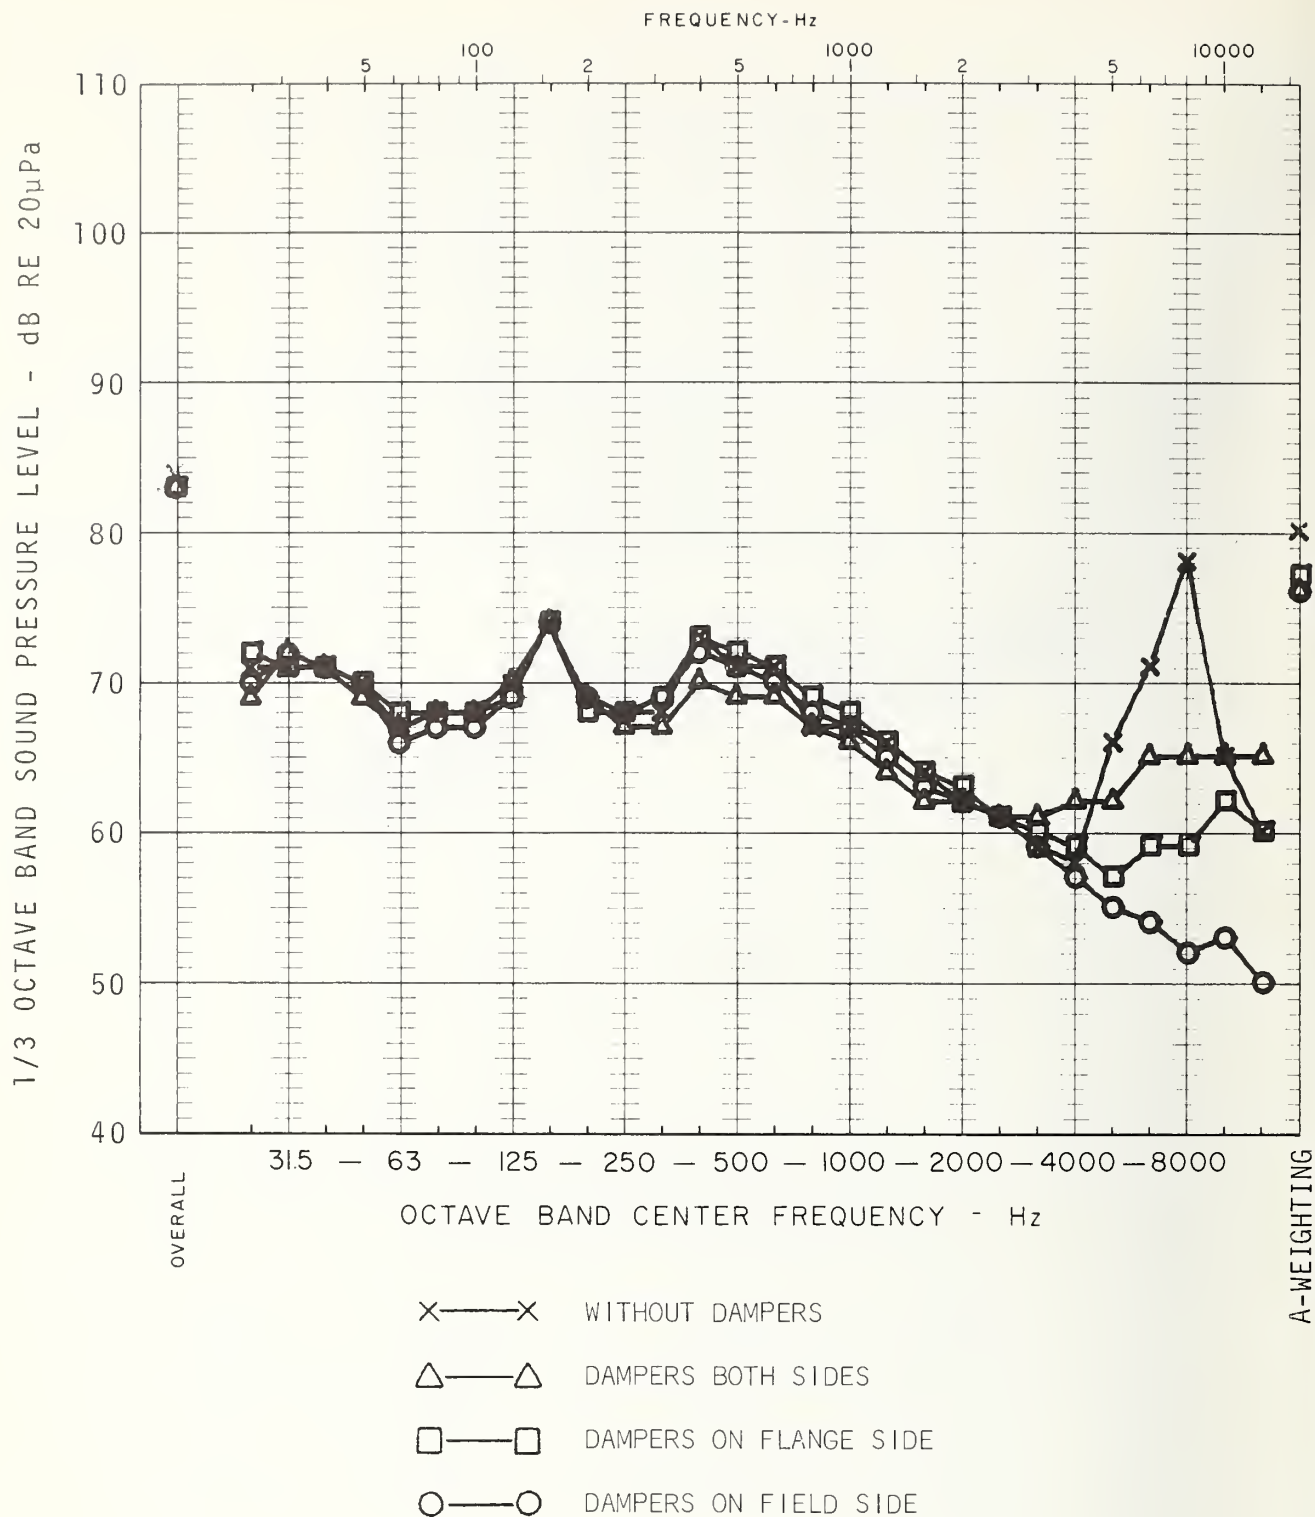
FIGURE 4-23. COMPARISON OF WHEEL SQUEAL WAYSIDE NOISE SPECTRA ON THE TURN TRACK FOR THREE RING-DAMPER CONFIGURATIONS  
CAR 606, PHASE VII TESTS, 9-20-78

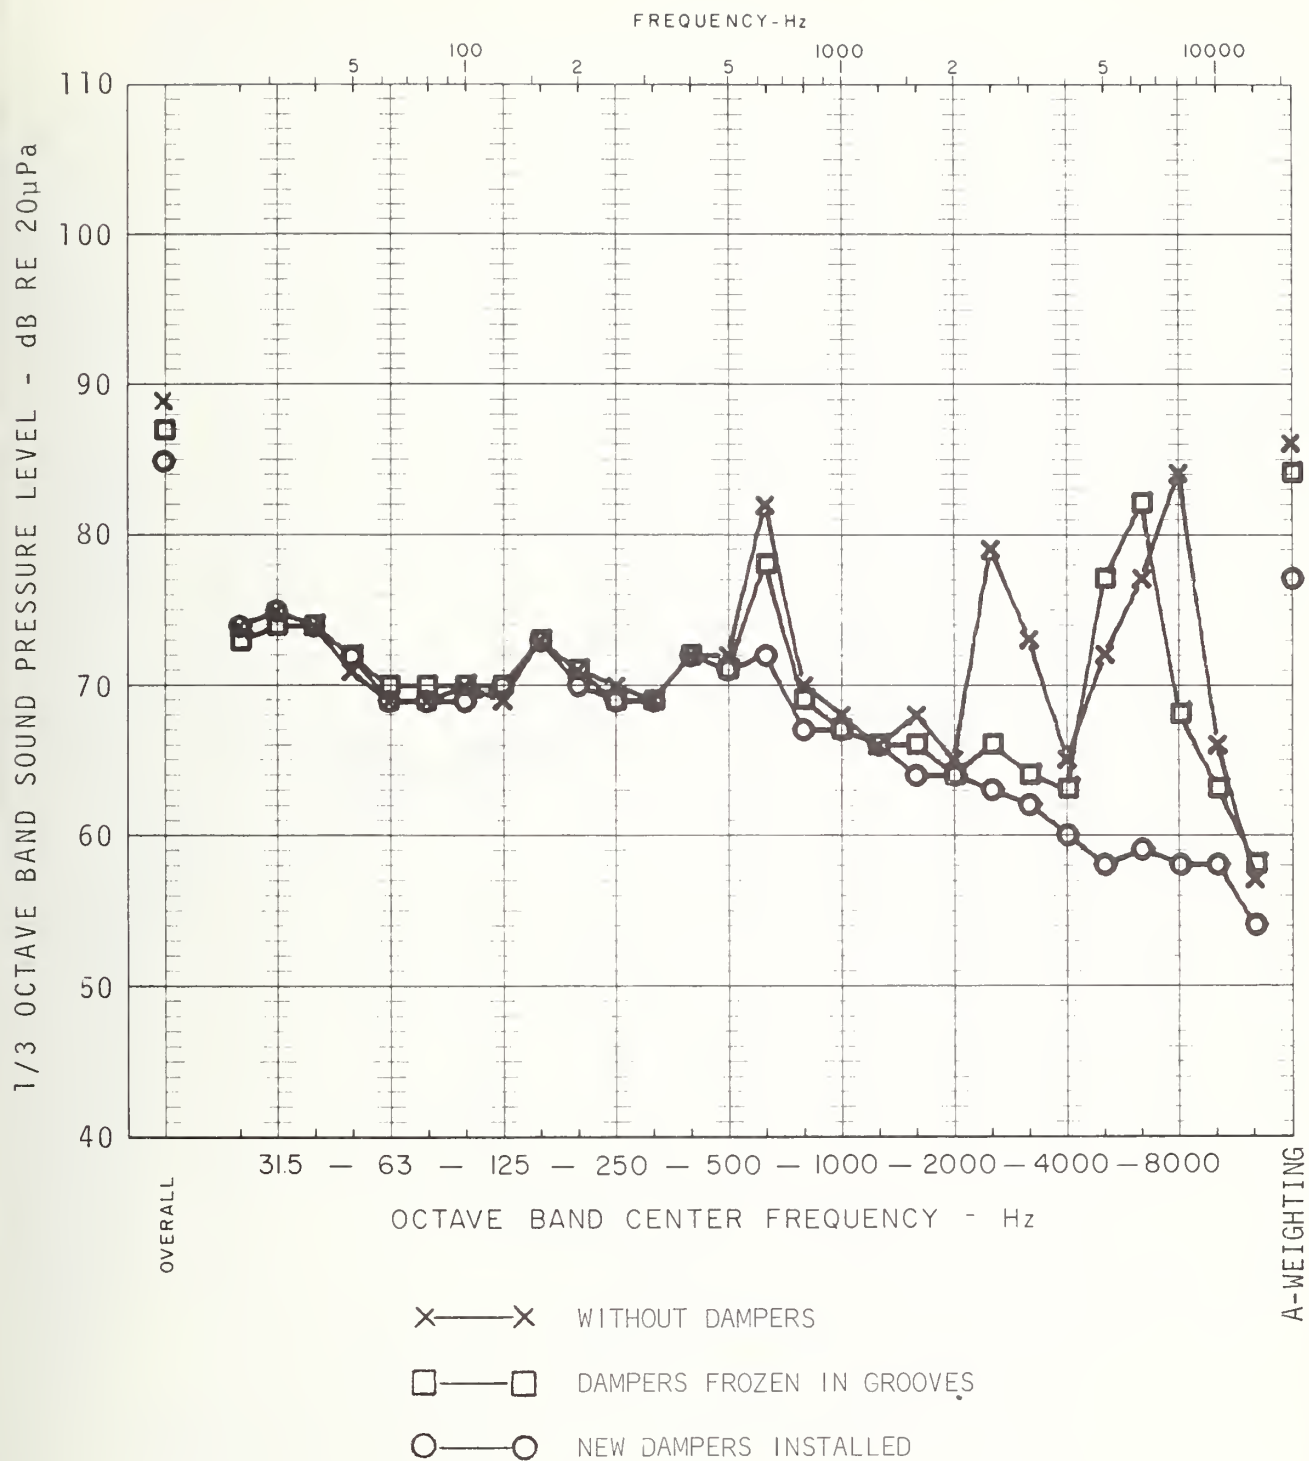
FIGURE 4-21. COMPARISON OF WHEEL SQUEAL WAYSIDE NOISE SPECTRA AT THE TURN TEST TRACK

CARS 607/644, PHASE VII TESTS, 9-20-78

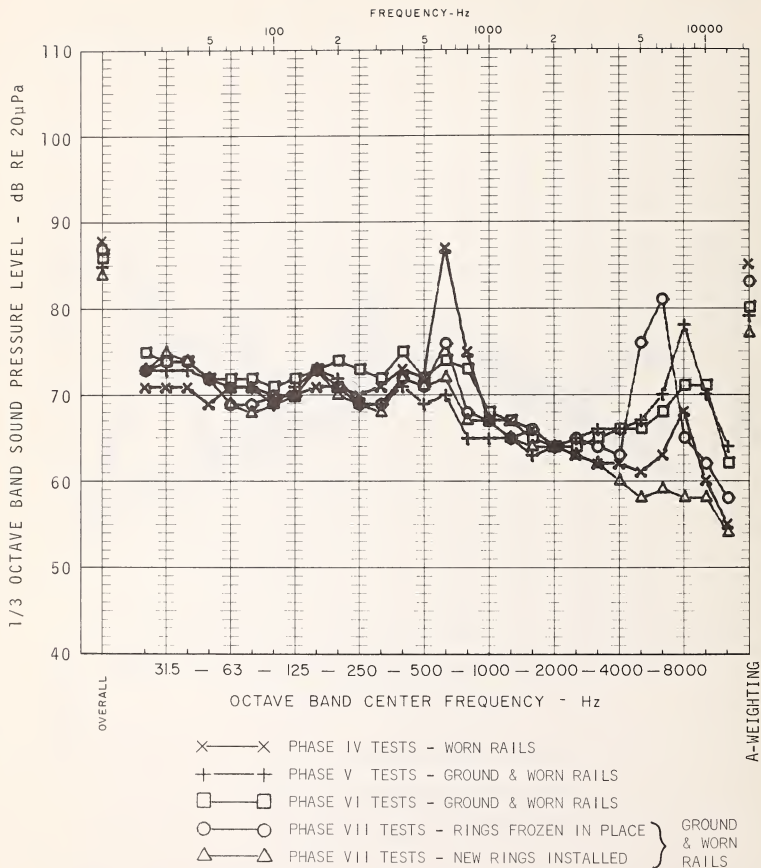
FIGURE 4-20 AVERAGE WHEEL SQUEAL WAYSIDE NOISE SPECTRA WITH RING-DAMPERS INSTALLED

CARS 607/644

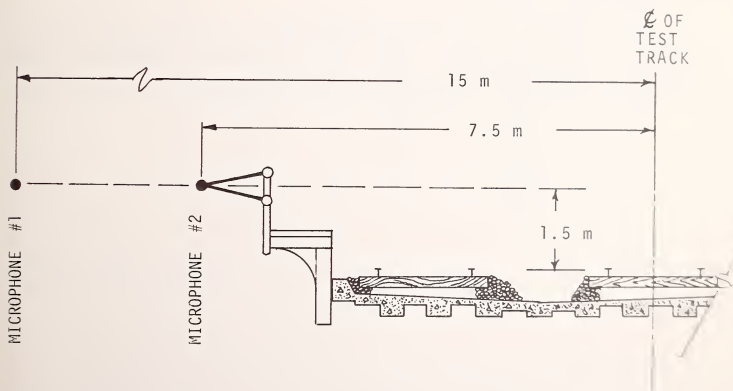
The locations of the two microphones relative to the elevated structure are shown in Figure 4-26. The microphone at 15 m was suspended above the street adjacent to the elevated structure on a rope stretched between the elevated structure and a sign bracket that extended approximately 6 m above the adjacent one-story building. Both of the microphones were approximately 1.5 m (4.9 ft) above the top-of-rail.

FIGURE 4-26. WAYSIDE MEASUREMENT LOCATIONS FOR EXTRA ELEVATED STRUCTURE TESTS

During the Phase IC measurements (September 2, 1976) an extra set of wayside noise tests were performed 15 m from the centerline of the Test Segment of the TW test track. These tests provide a direct comparison of the results at 7.5 m and 15 m from the track centerline and provide a basis for using the noise data at 7.5 m to estimate the noise levels at other distances within the adjacent community.

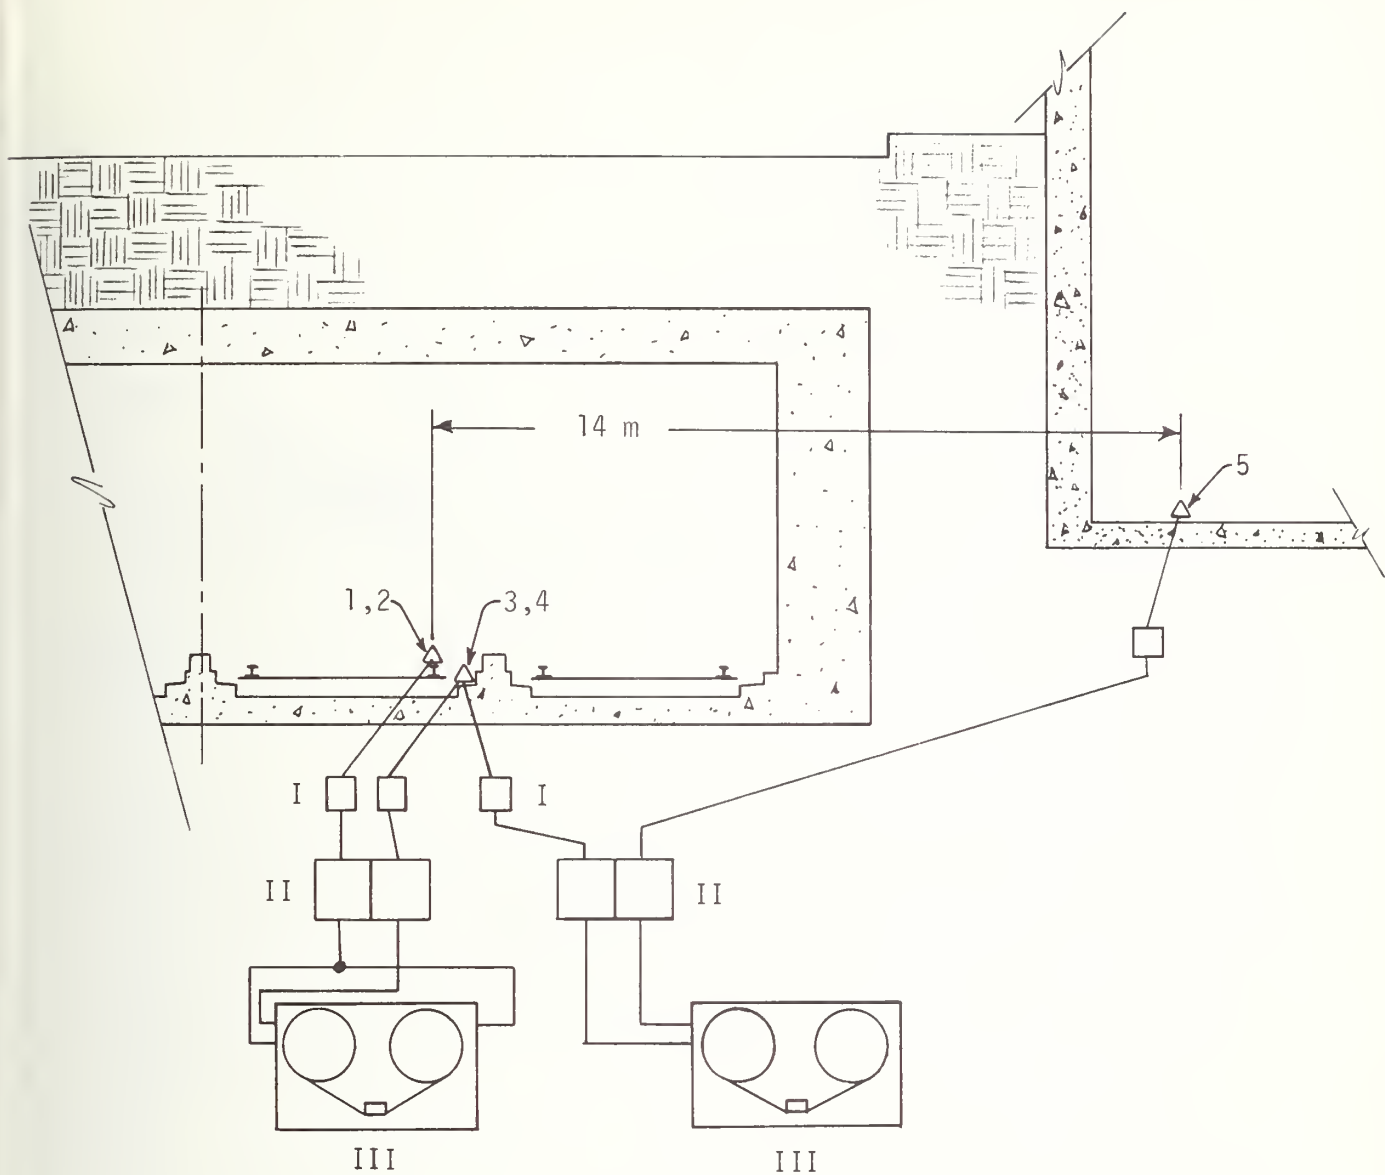
FIGURE 5-1. VIBRATION MEASUREMENT INSTRUMENTATION IN SUBWAY

The measurement system consisted basically of piezo-electric accelerometers (self-generating units), accelerometer preamplifiers to drive long cables, signal conditioning amplifiers and magnetic tape recorders. The tape recorders used were 3-channel machines which, in combination with the signal conditioning amplifiers, are arranged to permit recording either in the FM mode on all three channels or in the direct analog mode on one or two of the three channels.

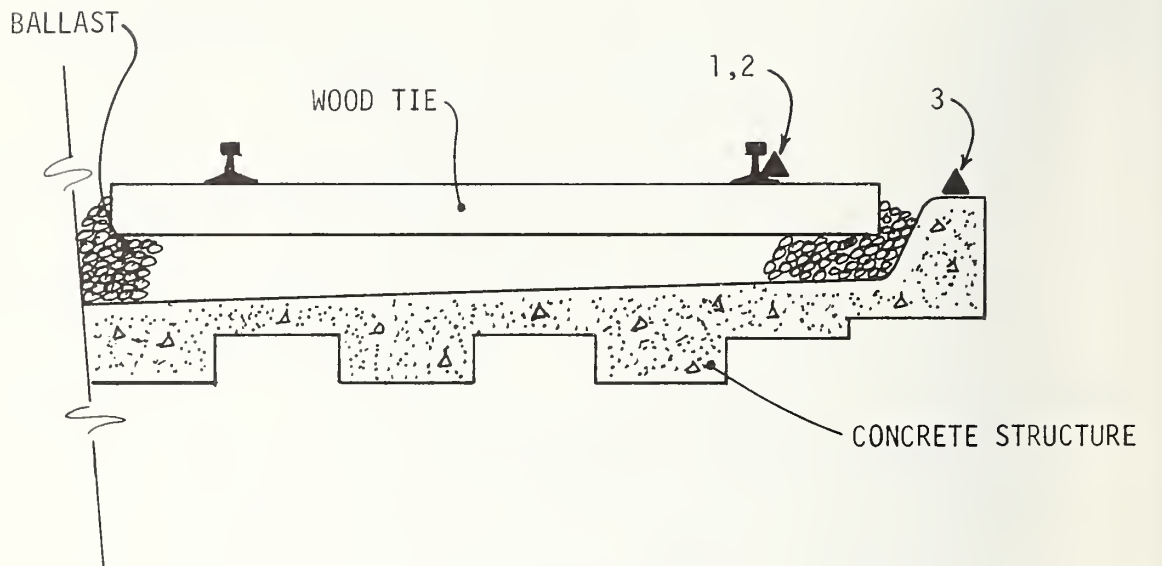
- ▲ ACCELEROMETER LOCATIONS (ORIENTED VERTICALLY)
- 1 RAIL, FOOT (DIRECT)
  - 2 RAIL, FOOT (FM)
  - 3 STRUCTURE (FM)

\*See Figure 5-2 for description of accelerometer locations.

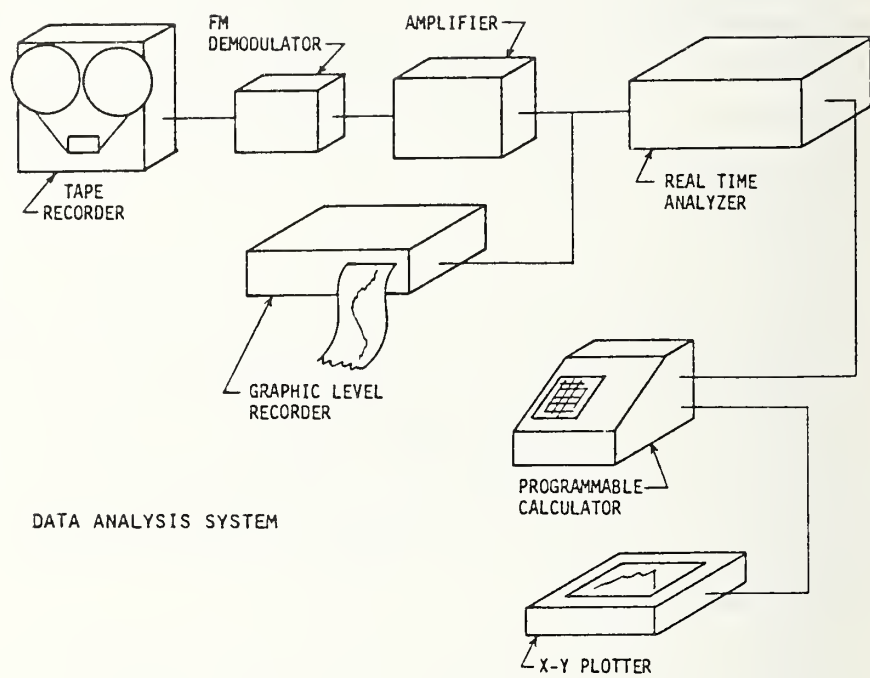
FIGURE 5-3. VIBRATION ANALYSIS EQUIPMENT

The analysis of the field data collected on magnetic tapes was performed with an analysis system similar to that used for the acoustic data. Figure 5-3 is a block diagram of the data reduction system for the vibration data. The amplified signal from the tape recorder is input to the graphic level recorder and the real time analyzer. The trace on the graphic level recorder is used to determine the appropriate location on the tape for analysis of the vibration data sample. Typically, sample lengths of 2 to 4 seconds

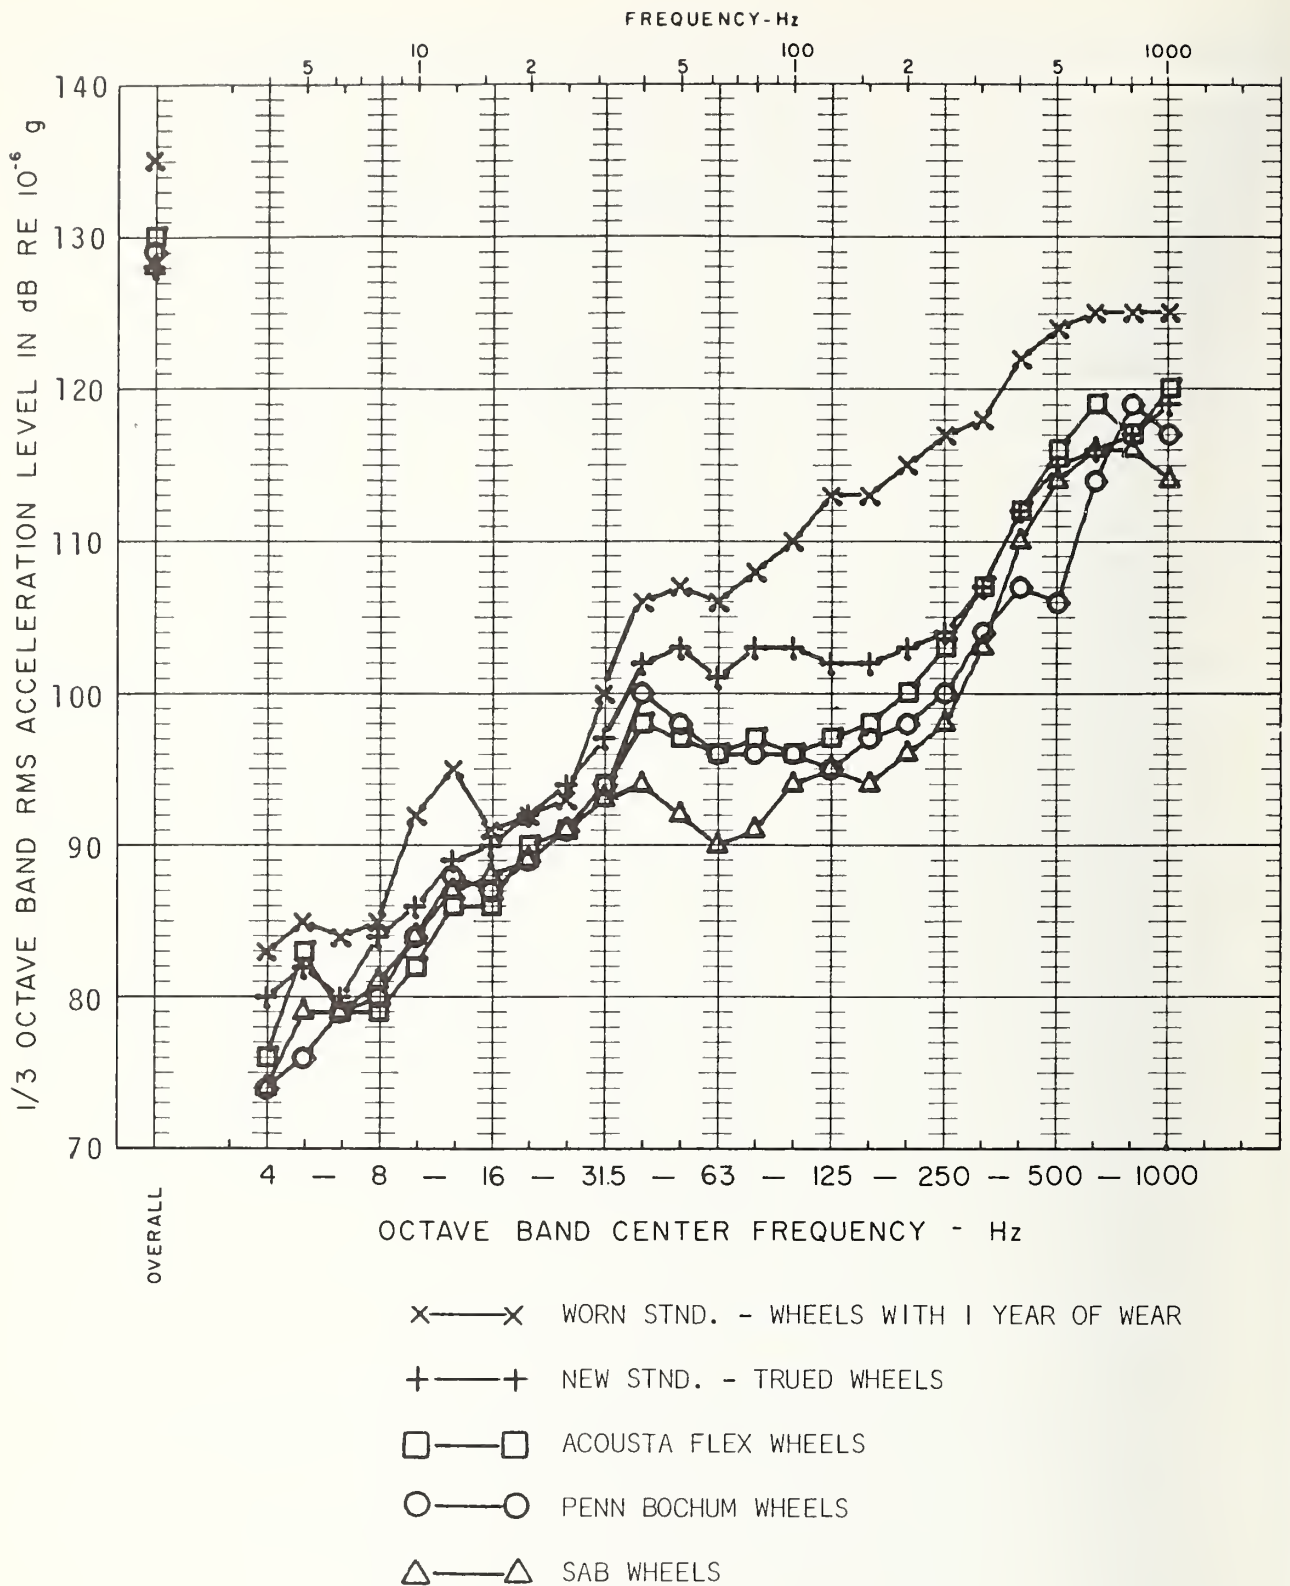
FIGURE 5-4. AVERAGE VERTICAL VIBRATION SPECTRA OF RAILS - TW TEST TRACK

PHASE IIA - GROUND RAILS

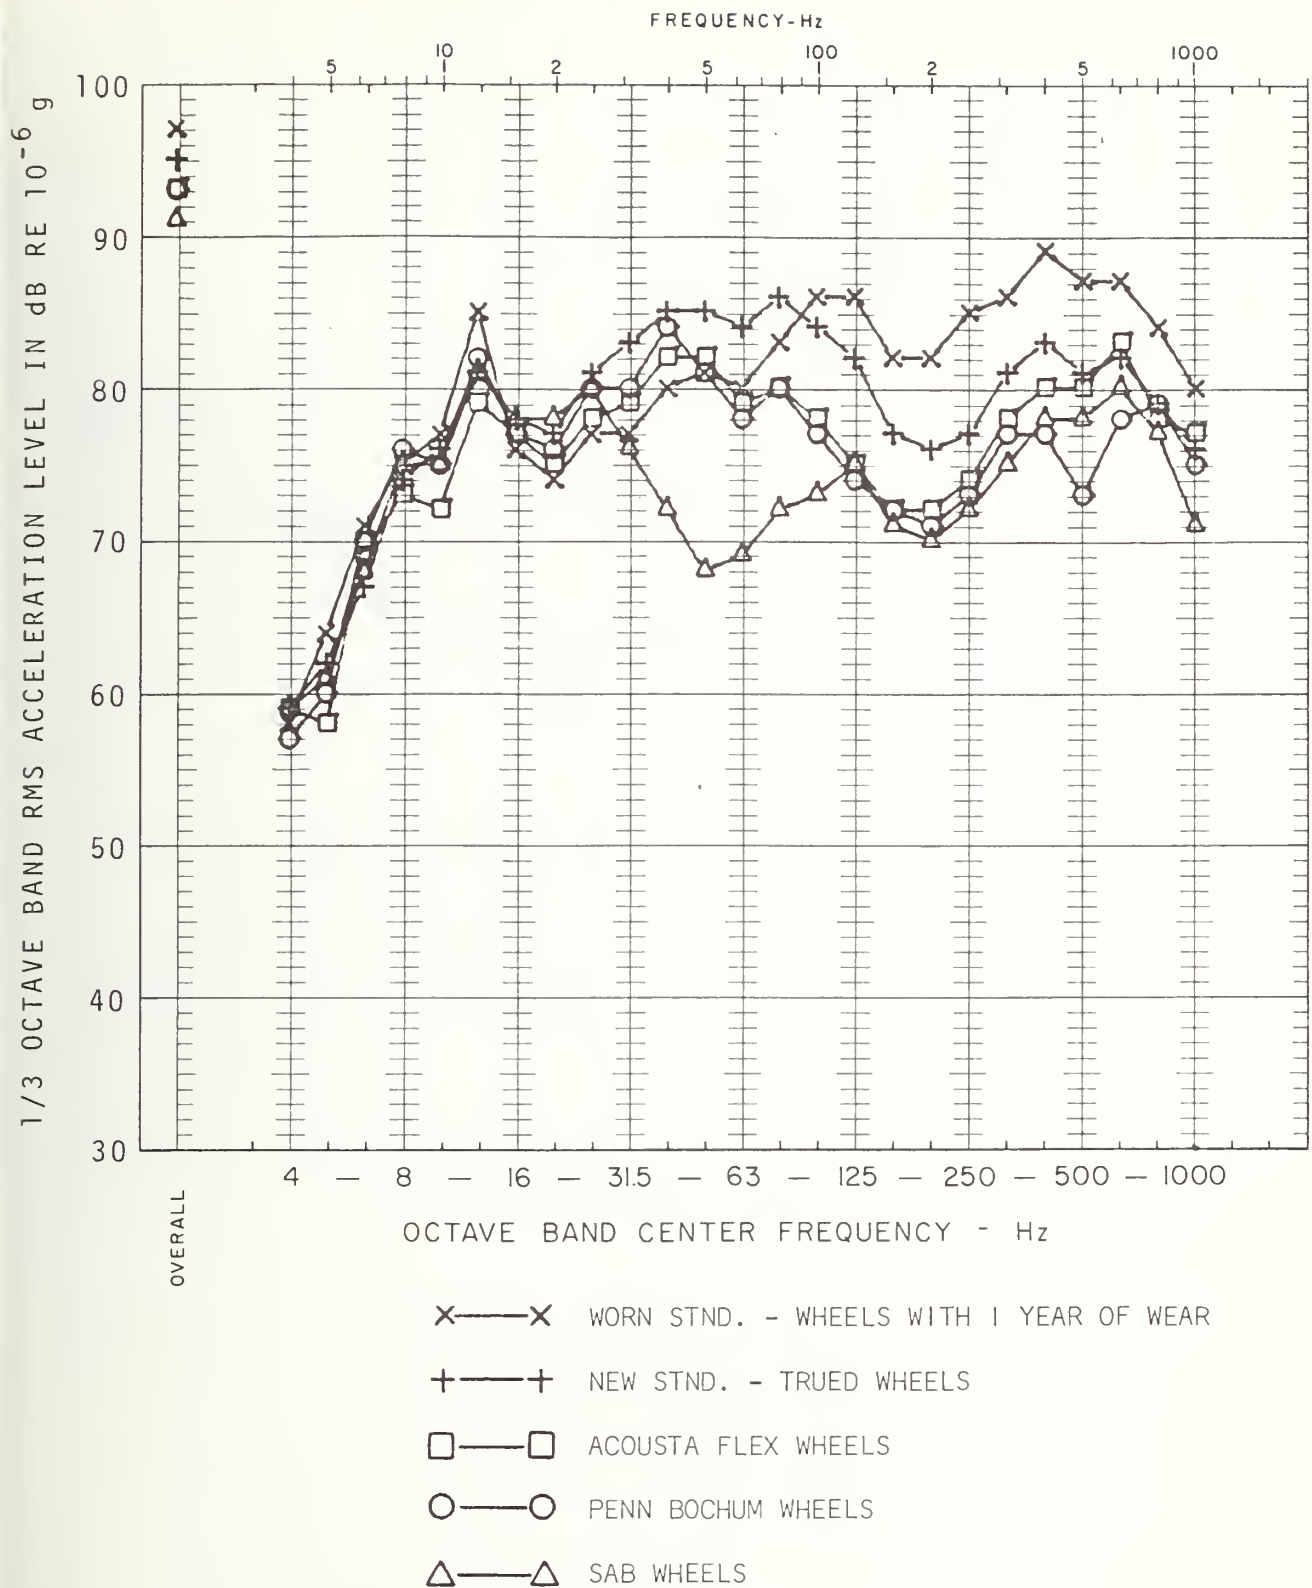
FIGURE 5-5. AVERAGE VERTICAL VIBRATION SPECTRA OF ELEVATED STRUCTURE, TW TEST TRACK

PHASE IIA - GROUND RAILS

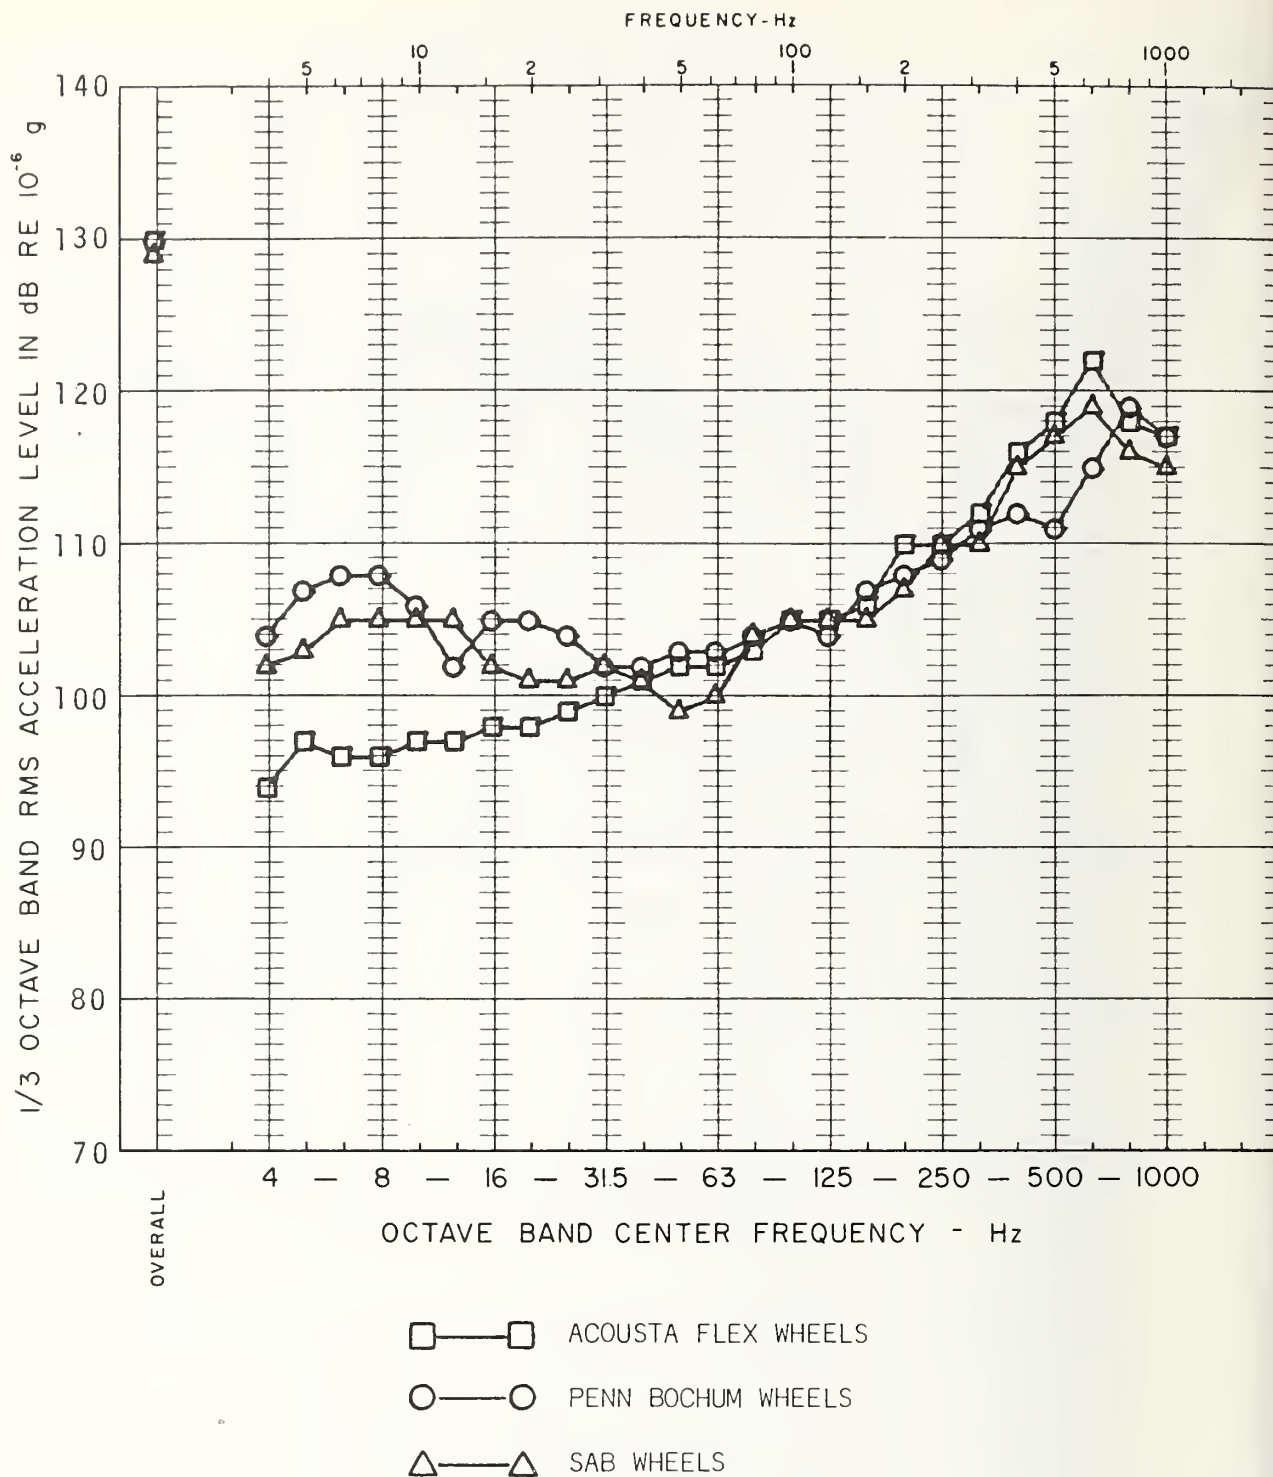
FIGURE 5-6. AVERAGE VERTICAL VIBRATION SPECTRA OF RAIL - SUBWAY TEST TRACK, TANGENT WELDED RAIL

PHASE IIA - WORN RAILS

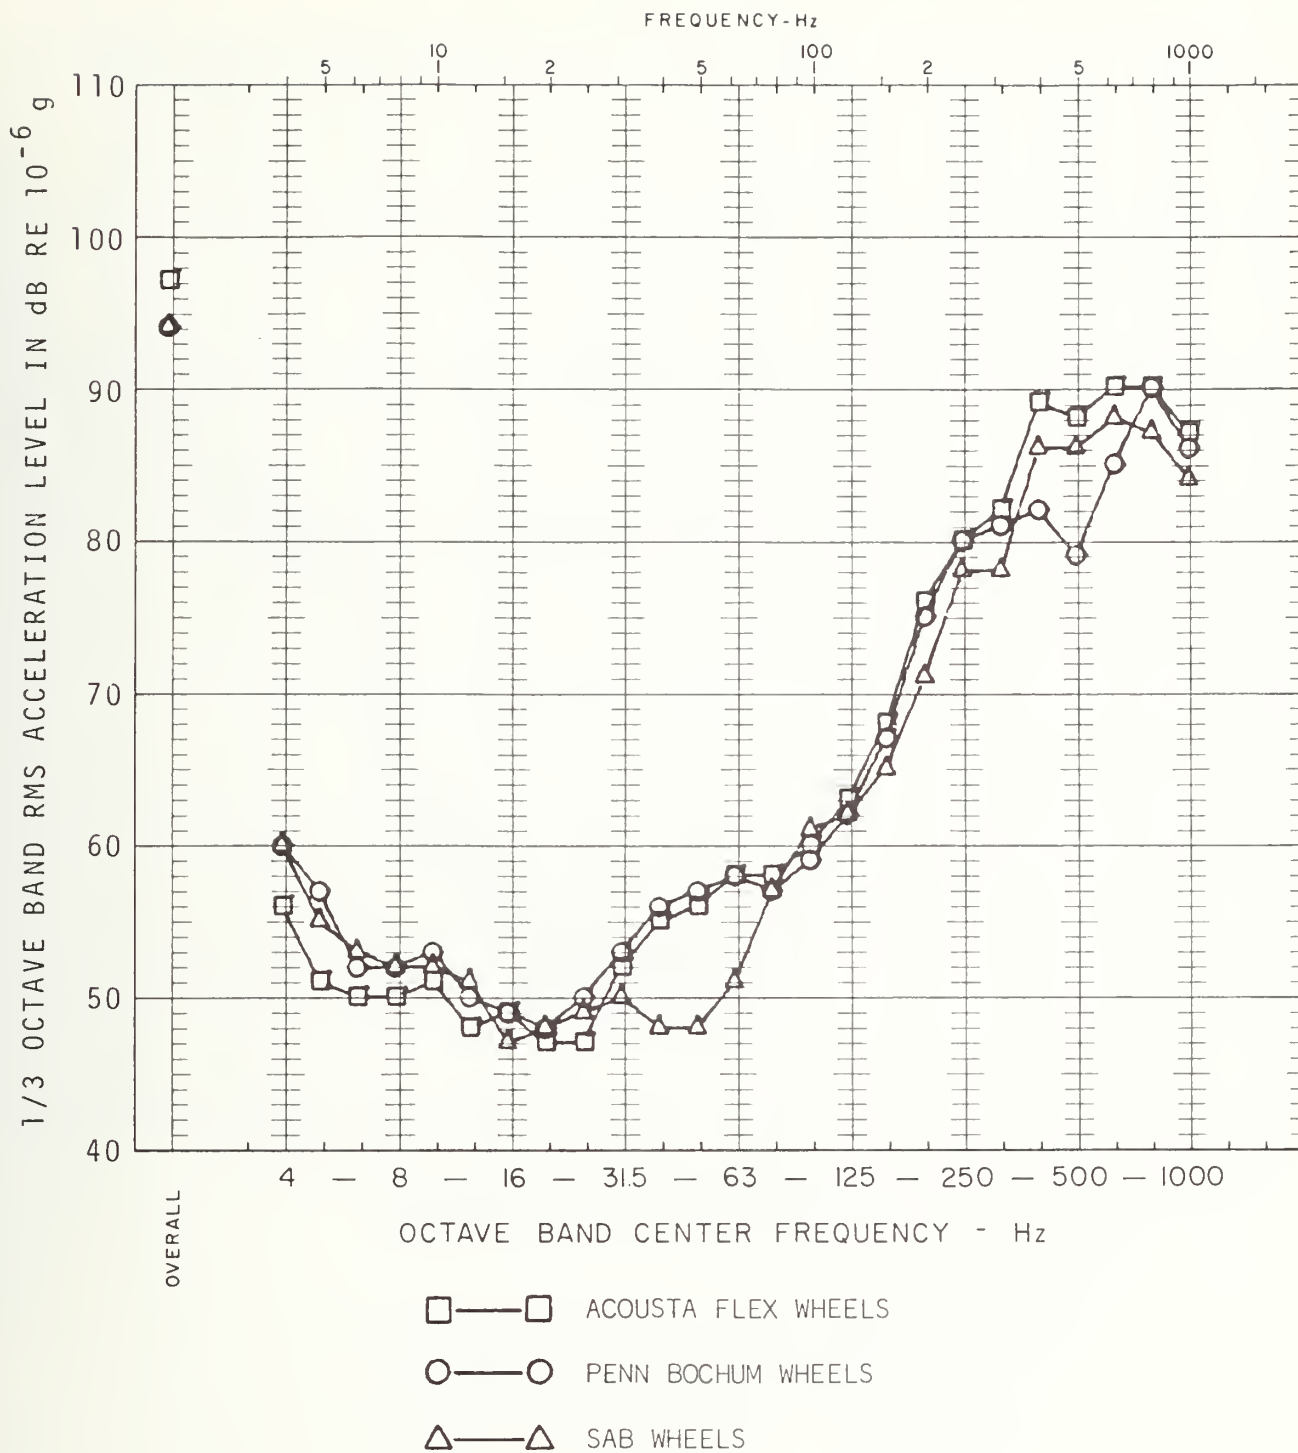
FIGURE 5-7. AVERAGE VERTICAL VIBRATION SPECTRA AT INVERT - SUBWAY TEST TRACK, TANGENT WELDED RAILS

PHASE IIA - WORN RAIL

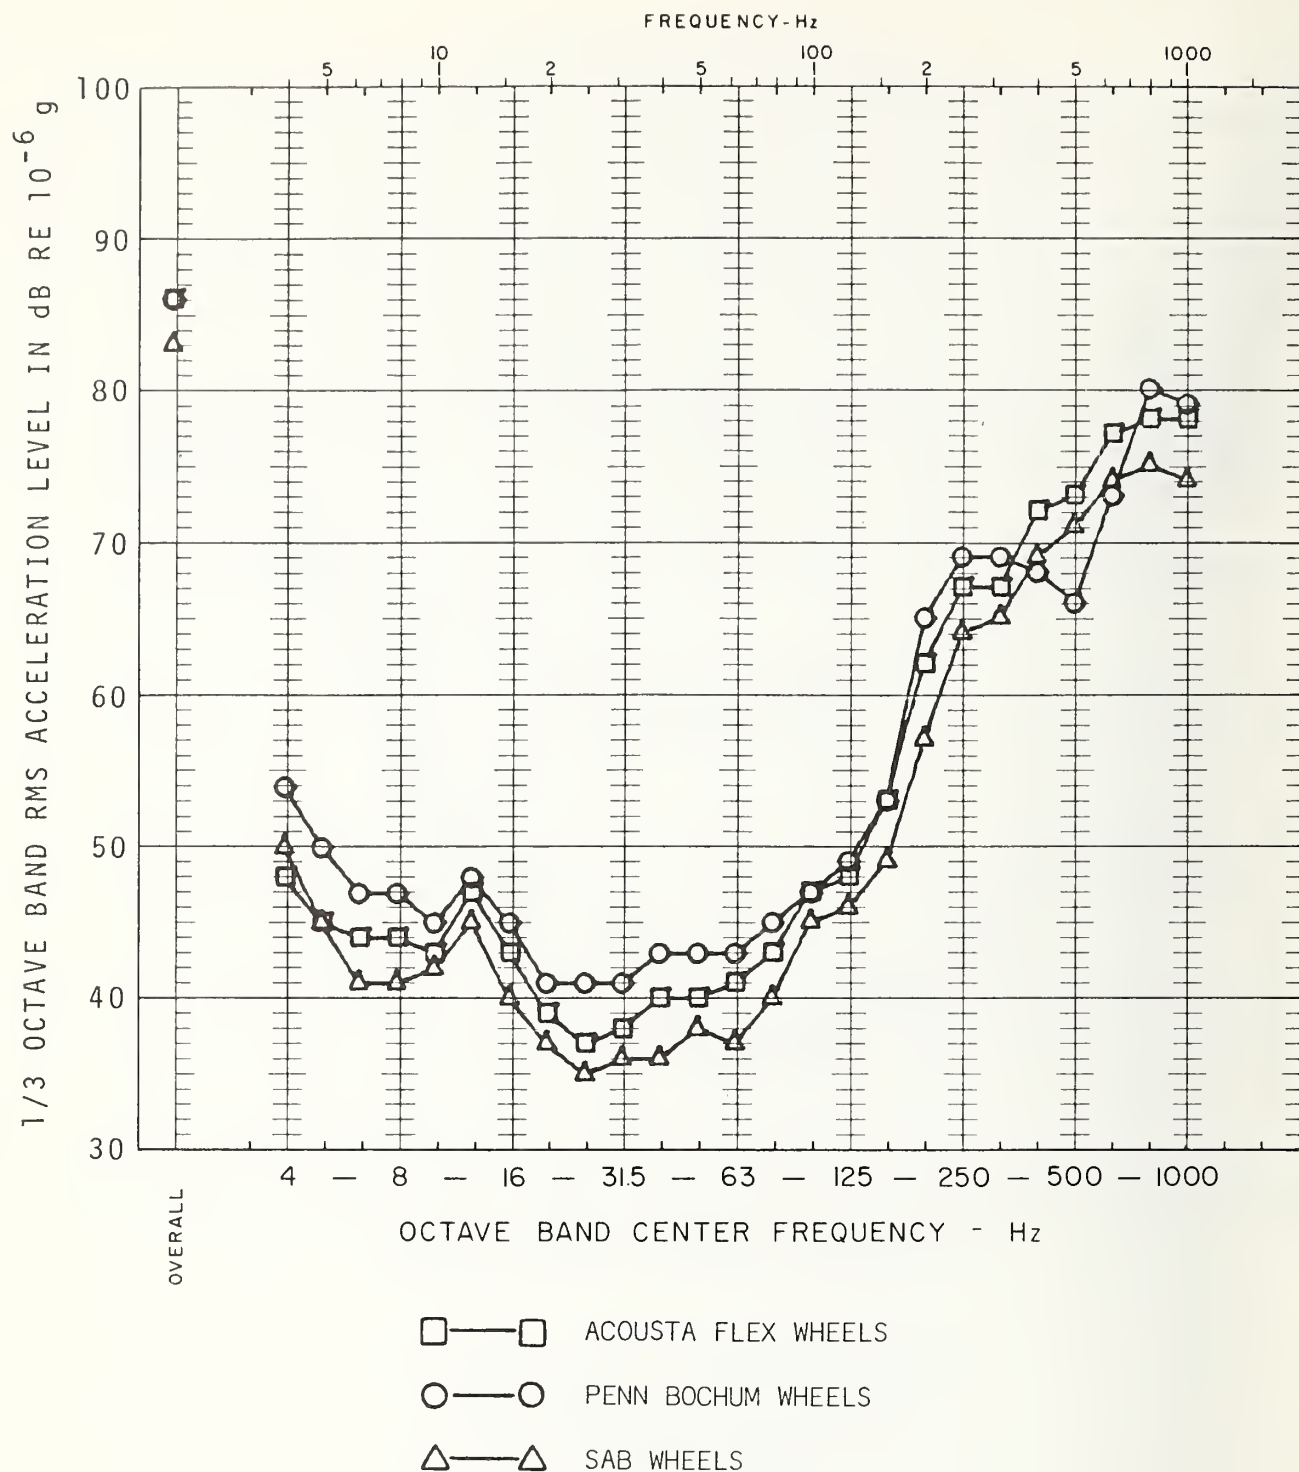
FIGURE 5-8. AVERAGE LATERAL VIBRATION SPECTRA AT INVERT - SUBWAY TEST TRACK, TANGENT WELDED RAILS

PHASE IIA - WORN RAILS

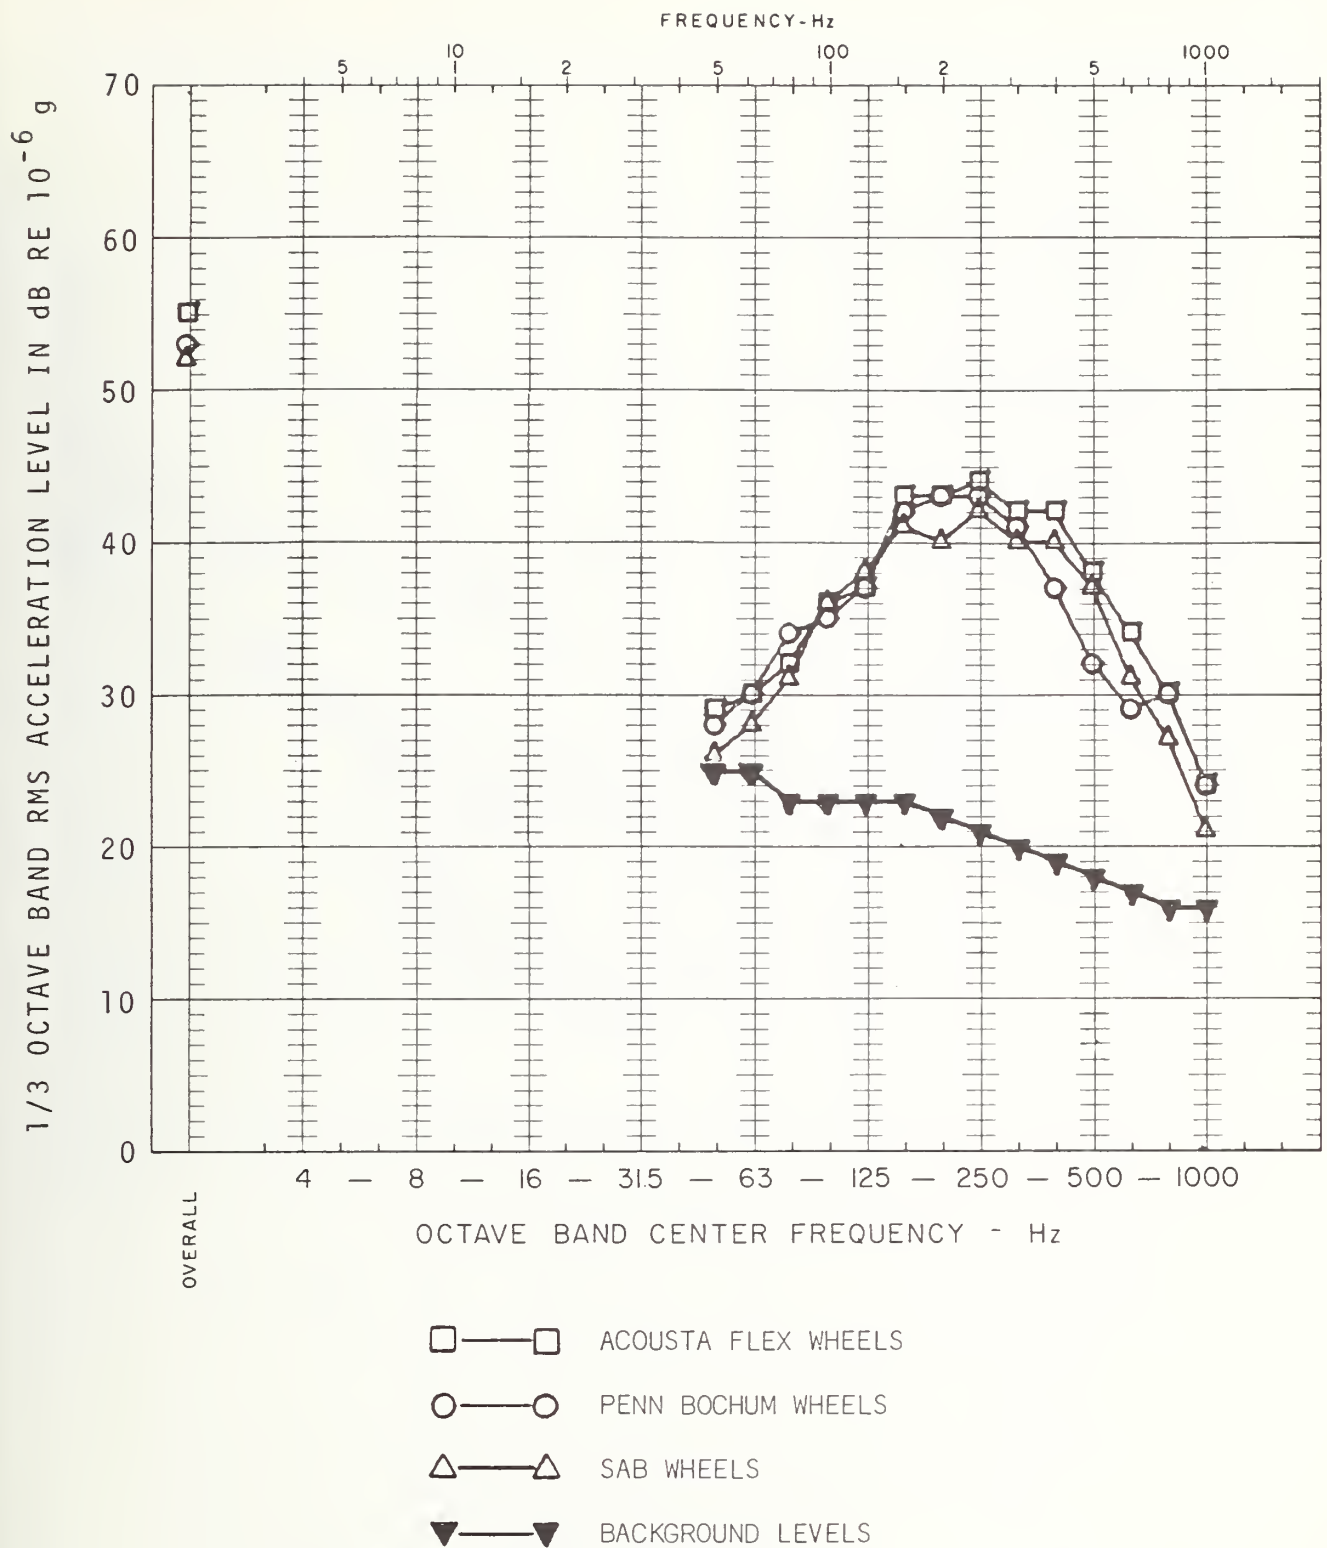
FIGURE 5-9. AVERAGE VERTICAL VIBRATION SPECTRA OF BASEMENT FLOOR -  
 SUBWAY TEST TRACK, TANGENT WELDED RAIL  
 PHASE IIA - WORN RAILS
